OREGON CORNER RESTORATION FORM

Section County	10 Morrow	Township Date:	<u>1S</u> Range April 17, 2019	23E	
•	esignation:	1S23E13			Condition Report Only Not found
Corner common to sections 3, 4, 9, and 10, T1S, R23E,				X	Remonumented Unrecorded
W.M., Morrow County, Oregon.				x	Surveyed in Referenced out

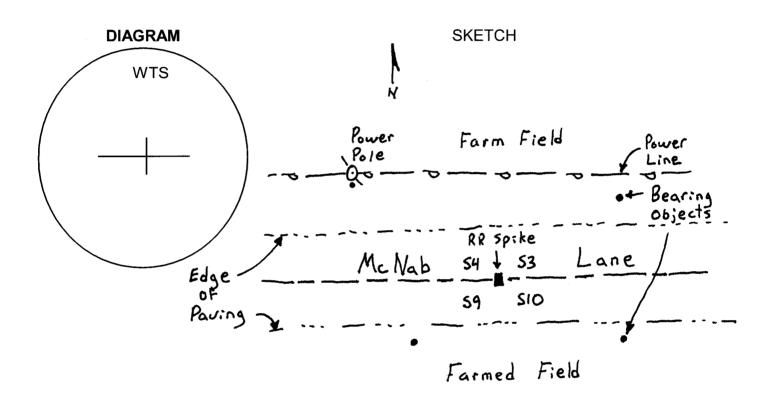
Monument and Accessories found: (condition and source) None. The point falls in the center of McNab Lane.

I set a railroad spike in the asphalt marked WTS and having an "X" cut in the top at the position determined by proportioning the departure and holding the east-west centerline of McNab Lane for latitude.

For references, I set four, 5/8" by 24" rebars with 1.25" orange plastic caps stamped WTS and 56295LS as described below:

an iron rebar bears N67°42'09"W, 64.45 feet on the south side of a power pole;

an iron rebar bears N59°28'00"E, 38.95 feet, 18 inches below the surface;

an iron rebar bears \$53°01'00"W, 39.51 feet, 18 inches below the surface;

an iron rebar bears S53°03'23"E, 42.81 feet, 18" below the surface;
