OREGON CORNER RESTORATION FORM

Township 1S 23E Section 2 Range April 17, 2019 County Morrow Date: **Condition Report Only** 1S23E21 Corner Designation: Not found Remonumented Corner common to sections 1, 2, 11, and 12, T1S, R23E, Unrecorded W.M., Morrow County, Oregon. Surveyed in Referenced out

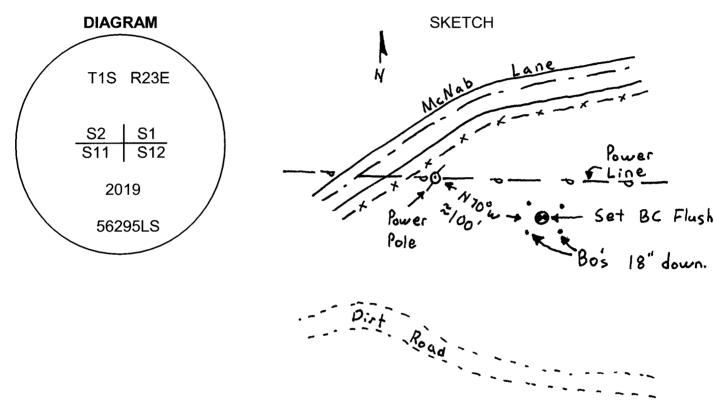
None. There is evidence that this area has been both plowed and burned.

MONUMENT (S) AND ACCESSORIES SET (Procedures and Description) I set a 2 3/8" brass cap on a 1 1/2" x 30" galvanized iron pipe 30 inches in the ground at the position determined by double proportion. I set a 6 foot steel guard post along the north side of the brass cap with a Morrow County monument sign attached.

For references, I set four, 5/8" by 24" rebars with 1.25" orange plastic caps stamped WTS and 56295LS as described below:

an iron rebar bears N50°34'29"W, 30.05 feet, 18 inches below the surface; an iron rebar bears N35°00'36"E, 31.01 feet, 18 inches below the surface; an iron rebar bears S53°16'43"E, 24.54 feet, 18 inches below the surface; an iron rebar bears S35°46'53"W, 25.77 feet, 18 inches below the surface;
