OREGON CORNER RESTORATION FORM

Section County	10 Morrow	_Township Date:	1SRange April 16, 2019	23E	
Corner De	esignation:	1S23G17			Condition Report Only Not found
1/4 corner common to sections 10 and 11 T1S, R23E,				X	Remonumented
W.M., Morrow County, Oregon.					Unrecorded
	•	-			Surveyed in
				Y	Referenced out

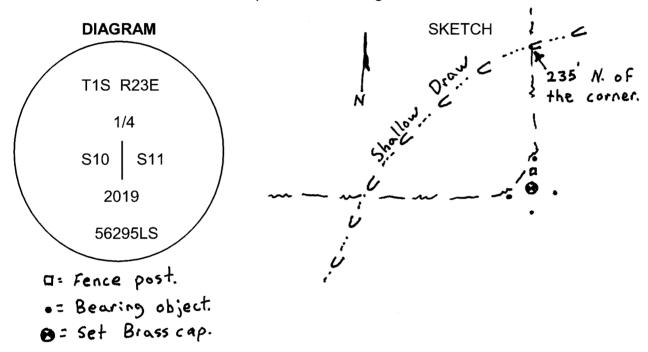
Found a corner in the field lines with plow lines running north and west with remains of fences.

At the corner point I set a 2 3/8" brass cap on a 1 1/2"x30" galvanized iron pipe 30 inches in the ground. The cap was stamped as shown in the diagram above. I set a fence post 12" diameter by 8 feet long 3 feet in the ground on the north side of the cap with a Morrow County monument sign attached.
